# Manhole Inspection Summary

Manhole # S19Y\_\_016MH

Insp Date: **6/3/08 12:15 PM**

**Location** Address: **2506 washington-james alley**

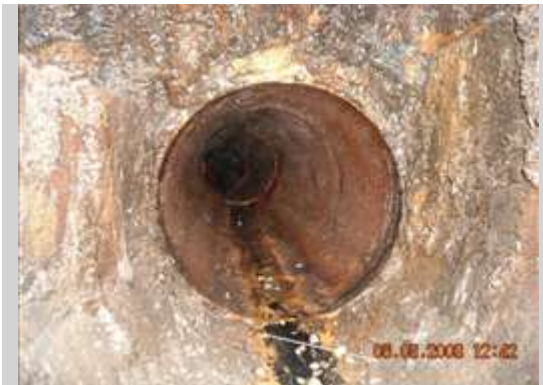
3 O'Clock Inflow

Pipe Height: **8.4** (in.) Rod and Bar (Angled)  
Pipe Material: **Clay** ☐ Pipe Lined  
Invert Depth: **6.32** (ft.) Flow Characteristics: **Slow**  
Deposits: ☒ None ☐ Mud ☐ Sludge ☐ Debris ☐ Grease  
Silt Depth: **0** (in.) Deposits Extent:  
Infiltration: **None** Pipe Seal Cond: **Unknown**

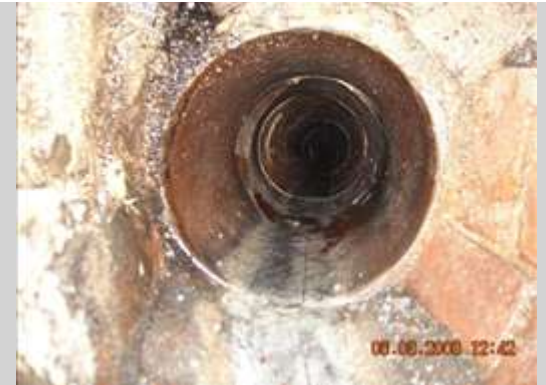
9 O'Clock Inflow

Pipe Height: **8.4** (in.) Rod and Bar (Angled)

Infiltration: **None** Pipe Seal Cond: **Sound**
